Umbauten, Erneuerungen, Retrofit

Photo report: WU_100

Roll lathe MFD WDK 850 revised by the WIAP AG

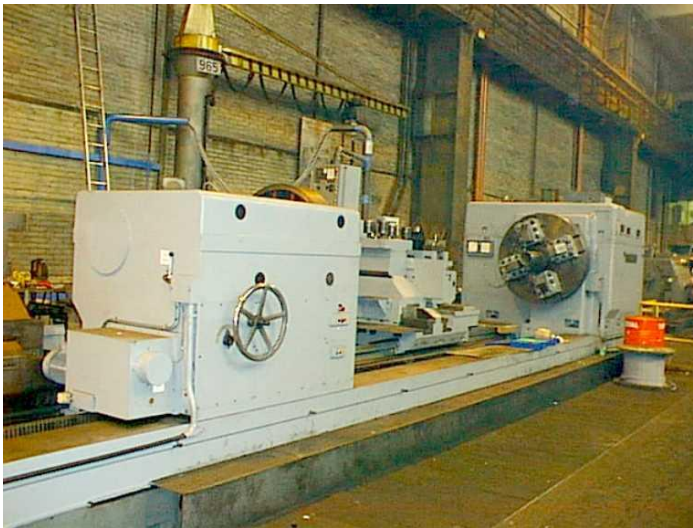
Figure 1: After the conversion of the WDK 850 MFD roll lathe, by WIAP AG.

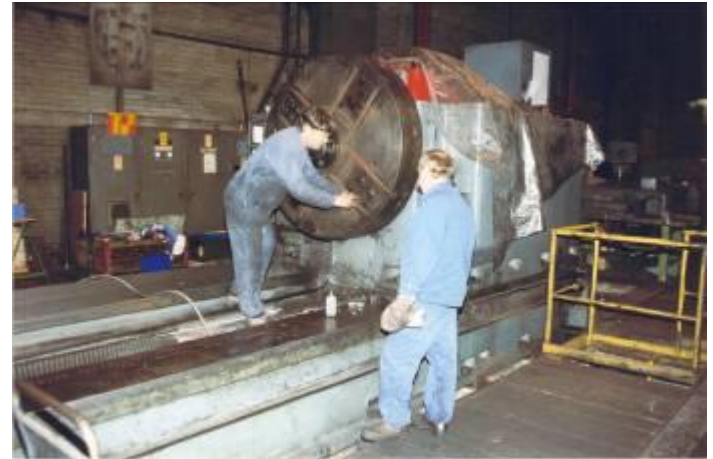
Figure 1a: Before the reconstruction of the 150 tons of machine Waldrich WDK 850 machine MFD. Before: The machine could only partially be delivered to Switzerland, for the revision. The breakdown of the 150 tons of machine was more expensive than to revise locally.

Task: The roll lathe must get control no new CNC. However, it should be totally revised. The operators were accustomed to copy itself, so no CNC. The transmission had a damage. The tailstock guidance was lowered by several mm and had to be re eingeschabt. totally revise the cross slide, all with a new sliding layer.

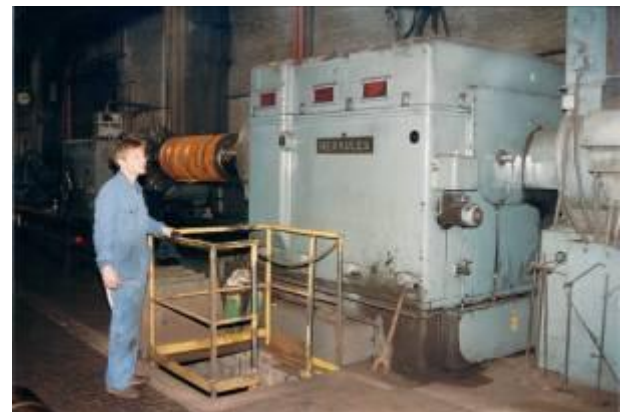
Figure 2: The machine has a spindle drive with 220 KW. The whole electrical system was renewed by us incl. The spindle drive.

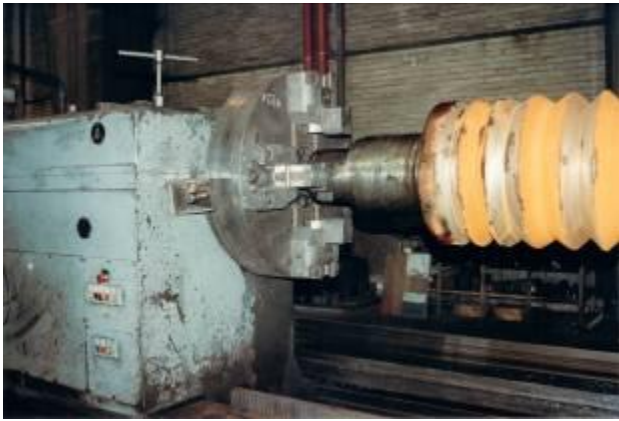
Figure 3: The claws box revised from scratch.

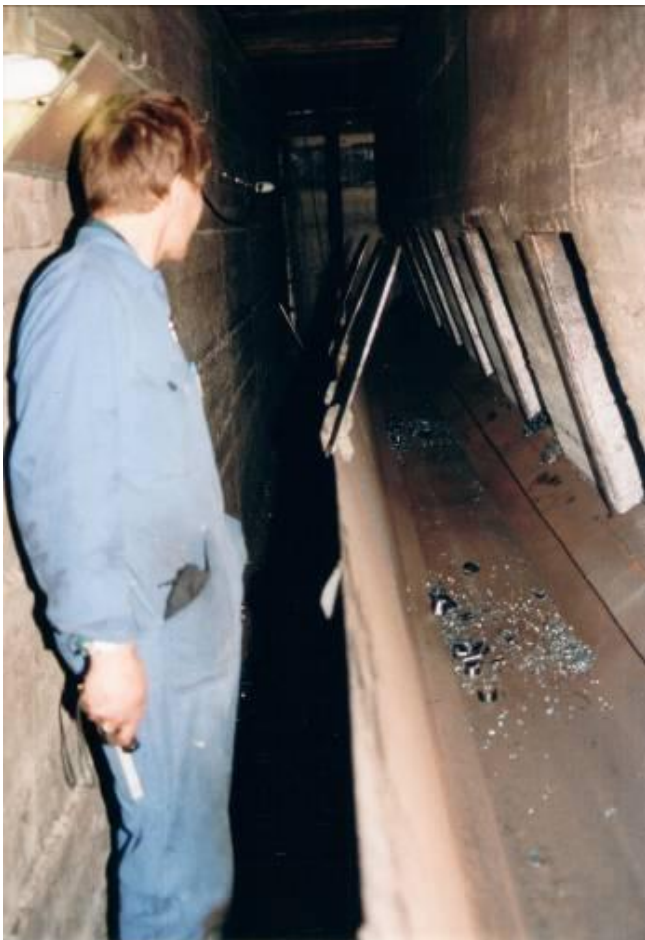
Figure 4: Under the machine is the chip tray. 220 KW and the large torque chips are so large as flat iron, removed here.

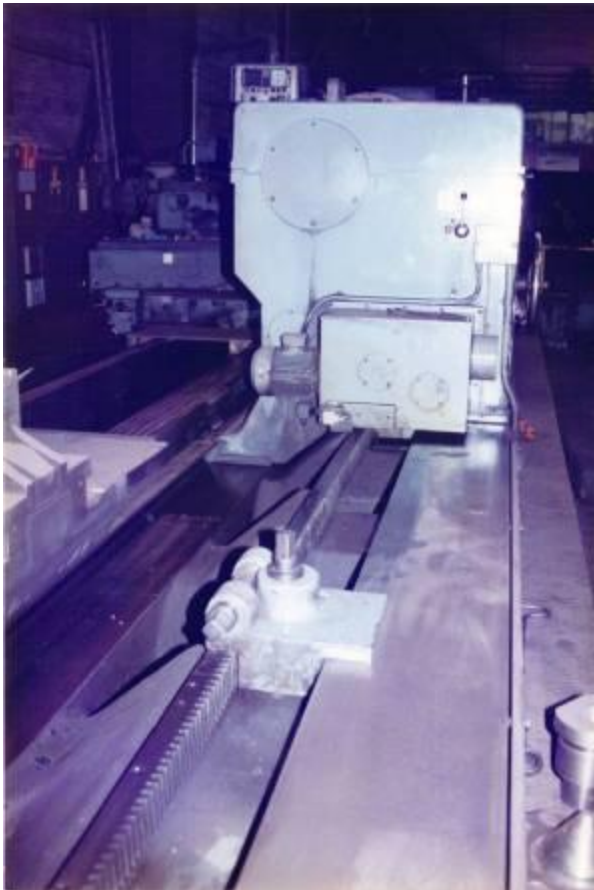
Figure 7: The guide to the tailstock had expired several mm.

Figure 12a: As a portable milling device is processed here. For reference, the front, not worn sled is taken leadership. It was re-milled heavily worn tailstock guide which went several mm from the center. disassemble the machine with 150 tons and be edited externally, would have been complex and expensive.

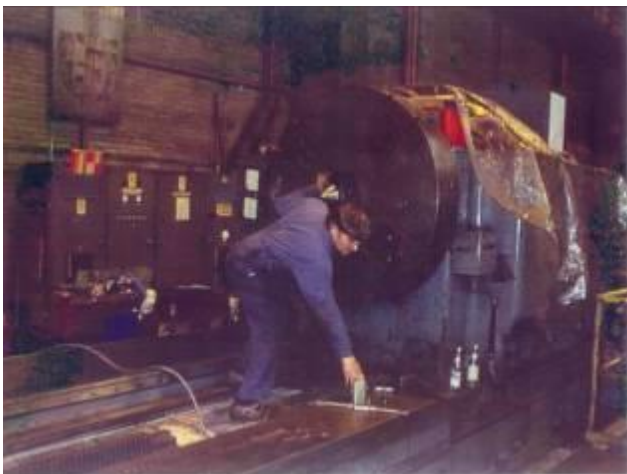
Figure 8: The dismantling of the Z-carriage, which went on the revision to us in Switzerland.

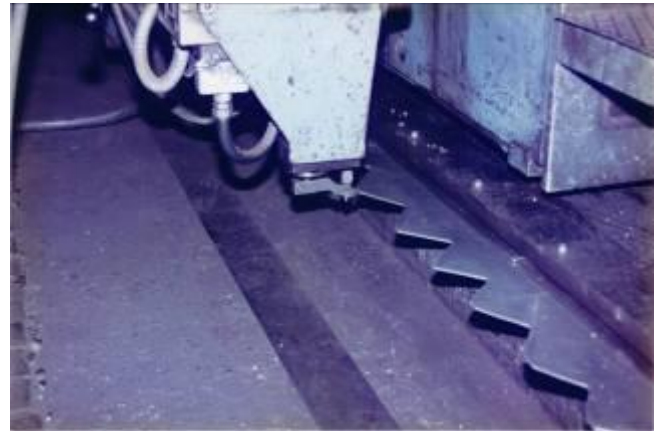
Figure 9: The machine is equipped with a copying device. The tracer by the company Heid. The electronics of tracer point from Siemens. This electronic device was no longer available. The WIAP AG had 4 new WIAP produce copy cards, according to the model Siemens. With new components, because the old ones were no longer to buy.

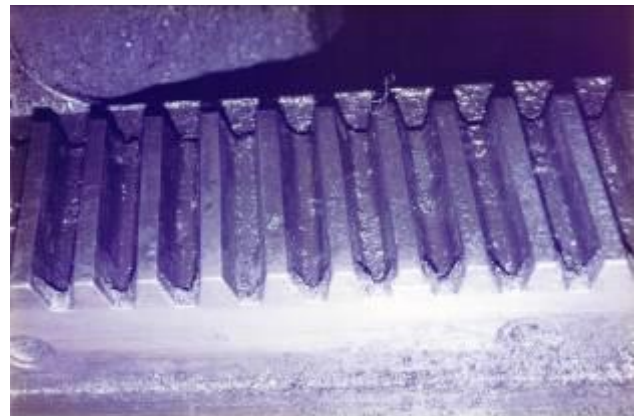
Figure 10: The rack of the Z axis was high above 150 mm. Erupted teeth; 3 racks had to be re-established after pattern.

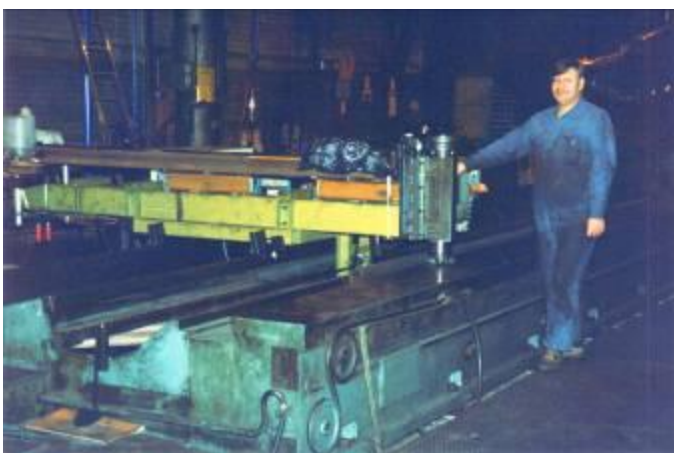
Figure 12: The leadership of the machine bed was at the customer site, milled by the reference to the Z axis. The milling device was fitted with a

headstock of a WIAP DM2A and the feed drive was made via a chain drive. The milling arm, prepared according to the method WIAP VDSF, reducing vibrations.

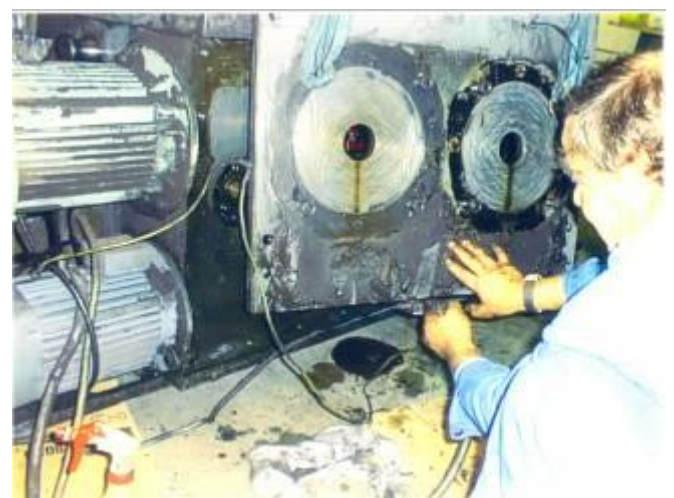
Figure 13: The whole cross slide of the roller turning machine was in a very bad condition.

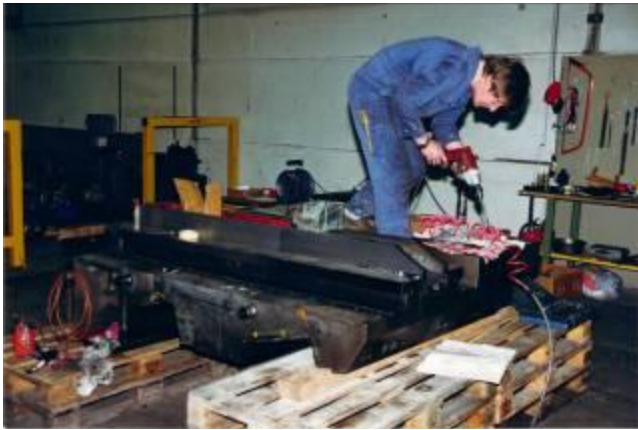
Figure 14: The carriage, who was about 20 tons, was brought to Switzerland for revision. Here, the decomposition of the carriage.

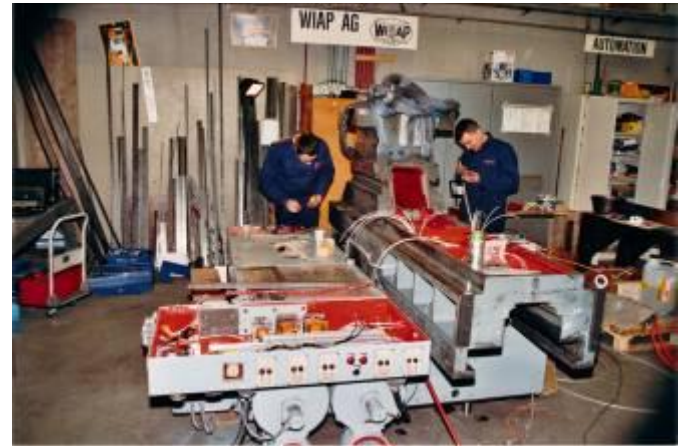
Figure 17: The carriage guide was re-occupied by SKC. The whole lubrication improved and renewed. The complete revision sled in Switzerland lasted 6 weeks.

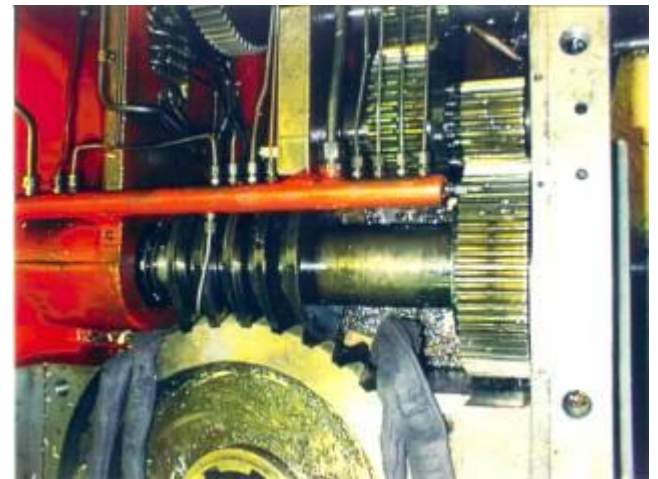
Figure 18: The whole longitudinal slide feed drive, which drive the rack was completely phased out.

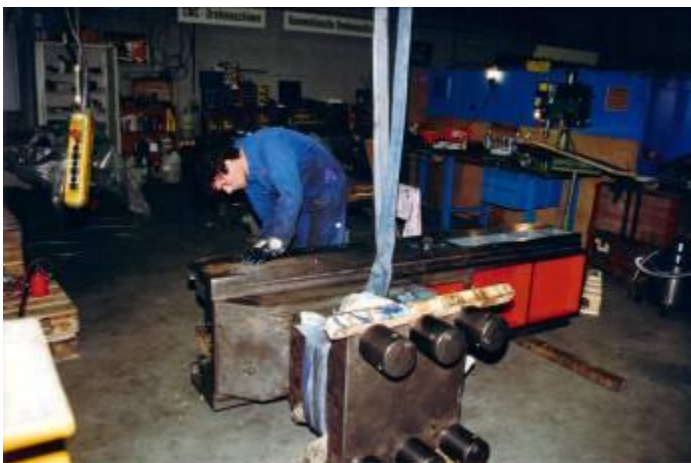
Figure 16: The sword holder of the roller turning machine is a very robust construction. He, too, had to be completely overhauled since it has experienced through the years of production, very large wear. The carriage was continuously loaded with a thrust of 20 tons.

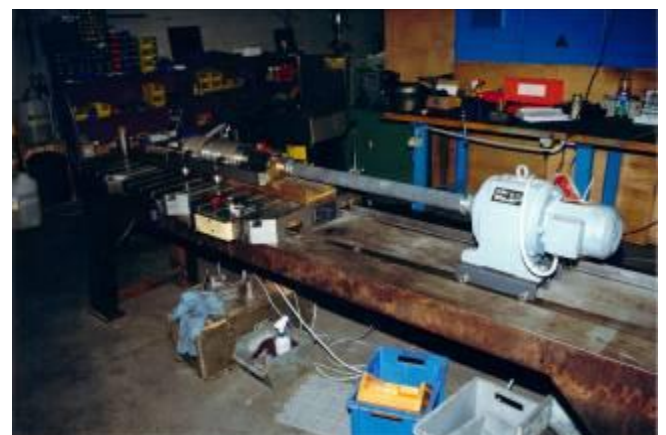
Figure 19: The leaked spindle was honed with a WIAP Hohn device.

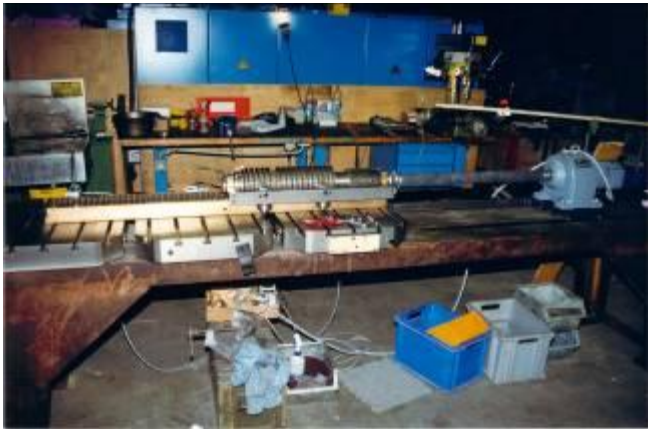
Figure 20: until the spindle again had the same measure, so that the spindle could be set backlash between the central zone and the outer zone two days had to be honed. The game was virtually gone.

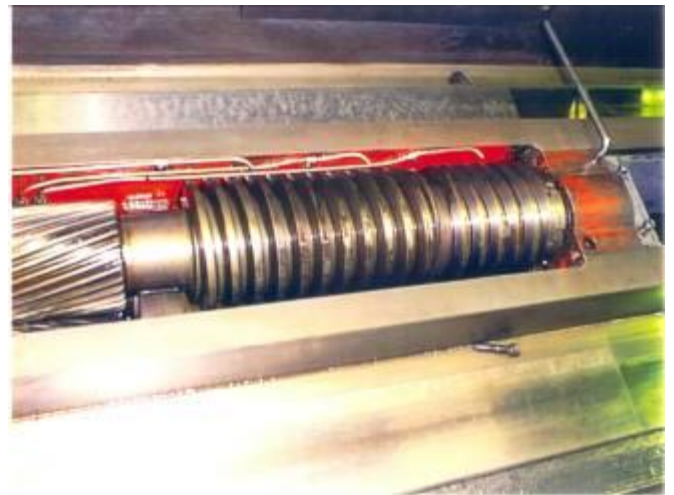
Figure 23: This longitudinal slide worm shaft expired in mm range. After the revision back in the 0.1 mm range backlash.

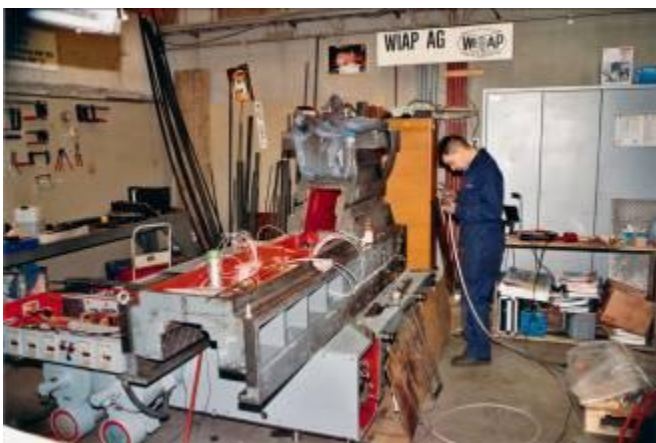
Figure 22: This, more than 20-ton sled was finally a revised sleigh with new SKC shows ect new eingeschatbten gears, lubrication system.

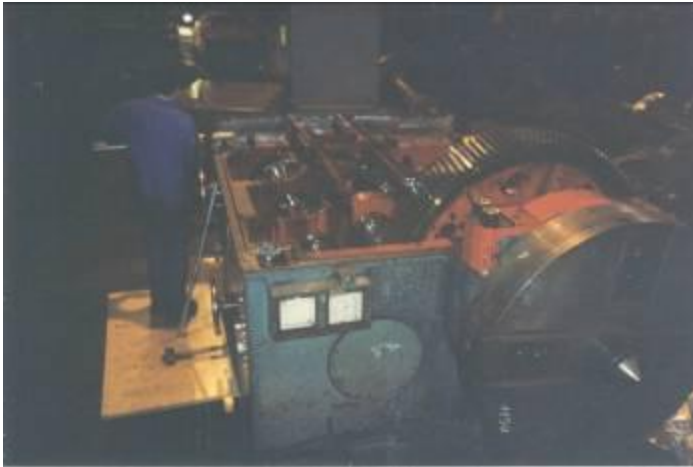
Figure 25: The transmission of the machine also had gear stages, which were no longer working. In addition, the spindle was not round.

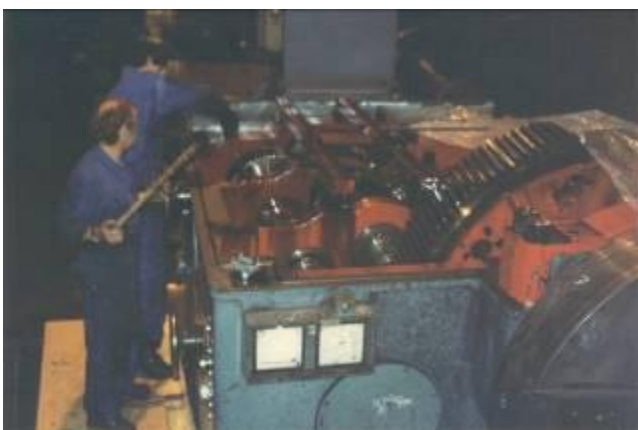
Figure 27: The separation was very expensive. Almost everything Press Associations where we needed the 2500 Bar Abpressvorrichtung. But it all went very well.

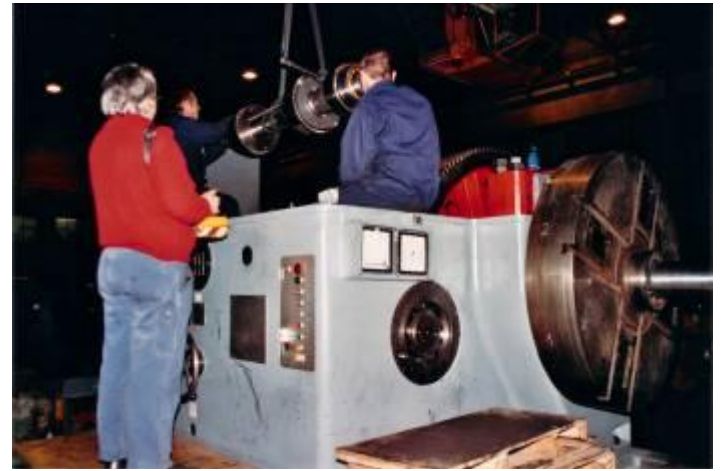
Figure 28: Finally, could be lifted out of the main transmission shaft. Then we were able to offer the defective gear. Thanks to a Swiss gear manufacturer, we quickly had everything organized. The customer ordered within 1 day. Two weeks later, we had the gear to pattern.

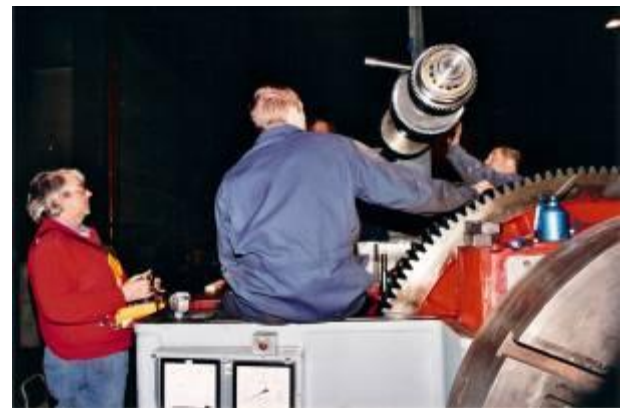
Figure 29: The installation worked very well. The transmission of the MFD, hats off, we can only praise the manufacturer. Sensational, like the whole structure was made accessible from above. Perfect, thanks to MFD, which is one of the best machines we've ever seen.

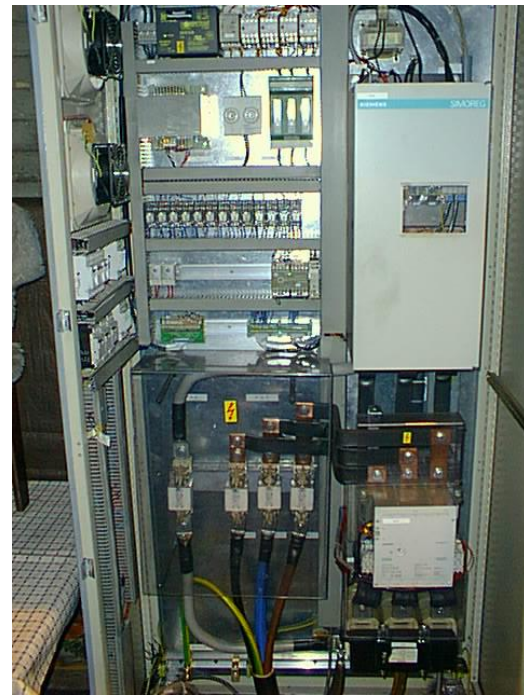
Figure 31: New electrical cabinet for the 220 KW Copying lathe

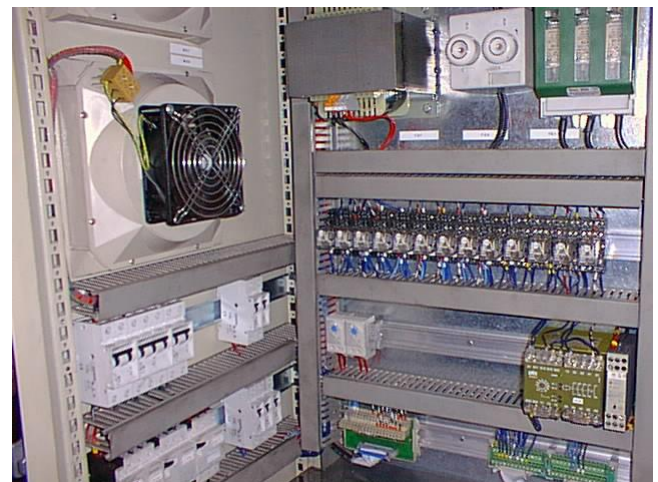
Figure 32: pavers electrical cabinet for the revised converted MFD roll lathe WDK 850 220 Spindeltrieb.
